**TNO report**

**2005-CVB-R0288[Rev.1]**

**Determination of the resistance to fire of a glazed  
partition of Glaverbel with a PYROBELITE  
EW60/12 type 2 in IGU fixed in a Jansen frame  
following NEN-EN 1364-1**

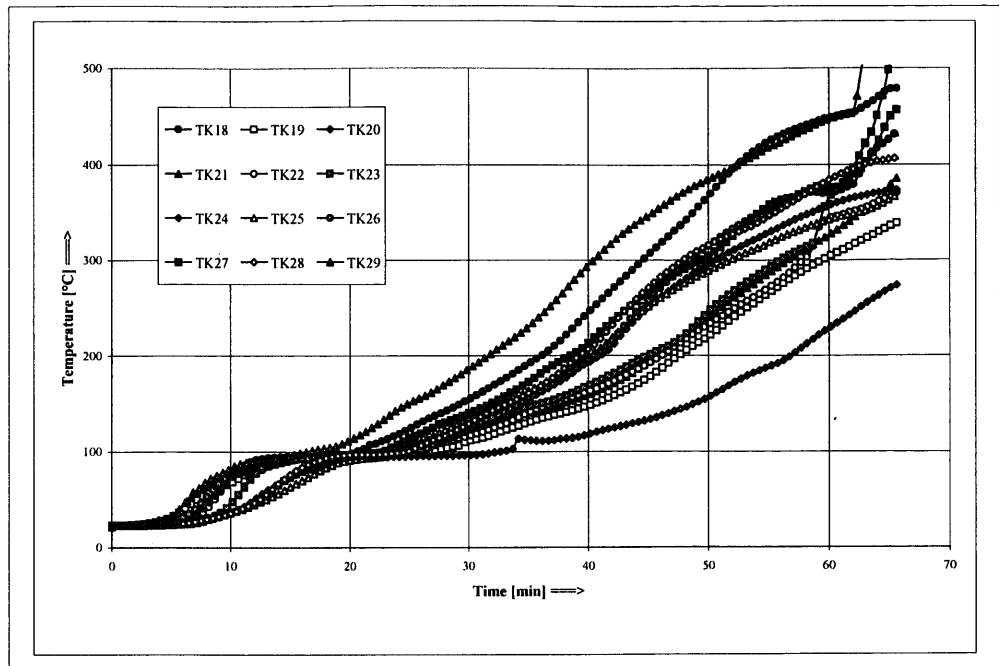
After heating for 31 minutes, thermocouple 29 indicated the frame temperature had increased  $>180\text{ }^{\circ}\text{C}$  (**end of thermal insulation**).

Figure C4: Temperatures on steel profiles.

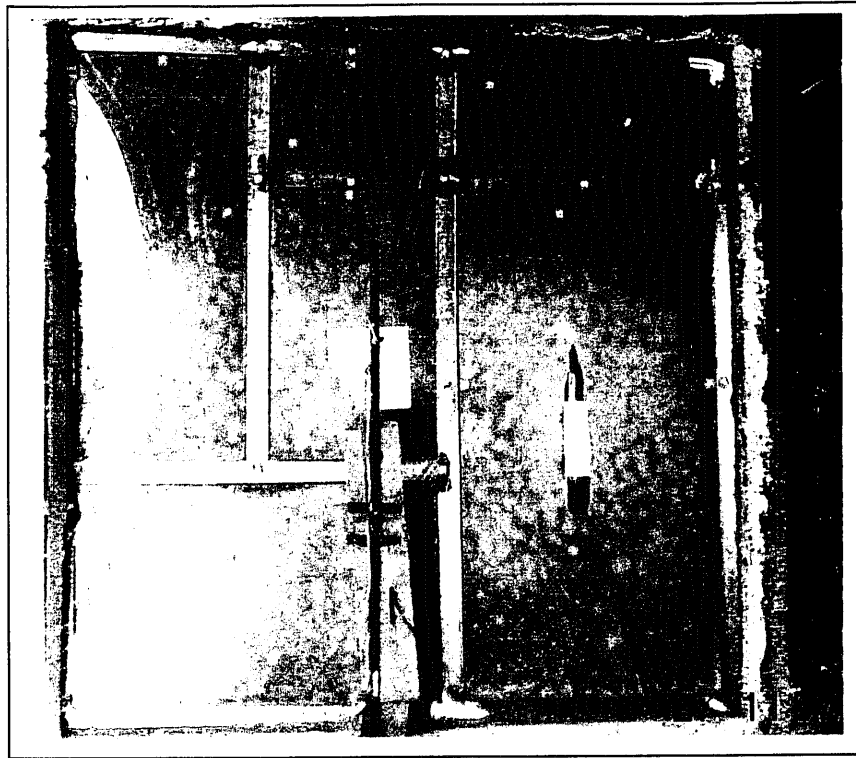
Picture 3, test specimen after 30 minutes.
