TEST REPORT

Fire test of glazed elements according to NS-EN 1364-1:1999

FKN Fire window E 30

Test of two glazed elements for 30 minutes fire resistance according to EN 1364-1 Annex A. The frames were made of Pine. One element, containing 2 glass panes, had insulating glass of type Pyrobelite 12EG 16-15-6 mm. This element was exposed towards the glazing beads made of aluminium and the 6 mm float glass was on the unexposed face. The second element, containing 2 glass panes, had glazing beads made of Pine on the unexposed side. This element had 12 mm Pyrobelite glass.

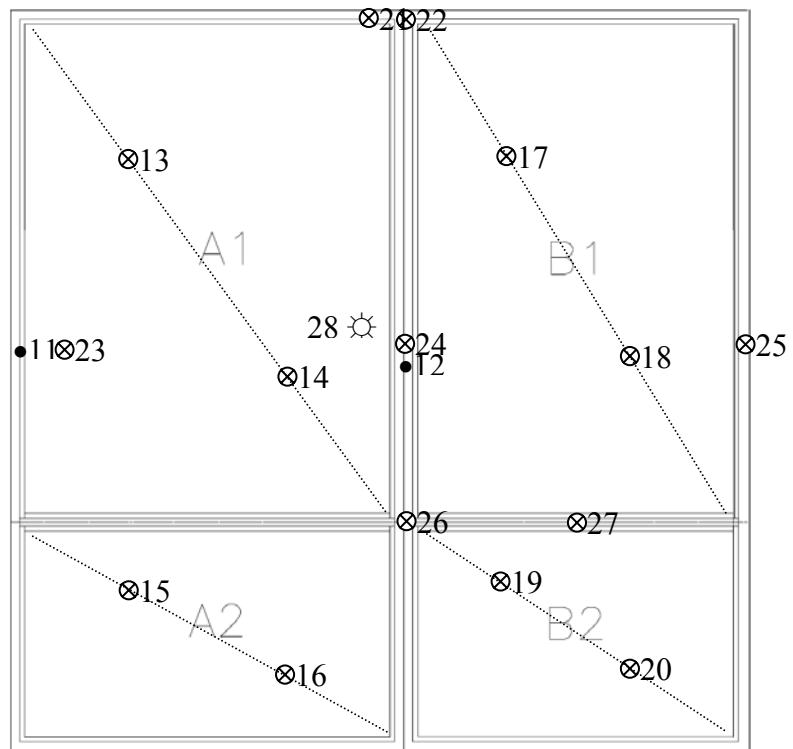
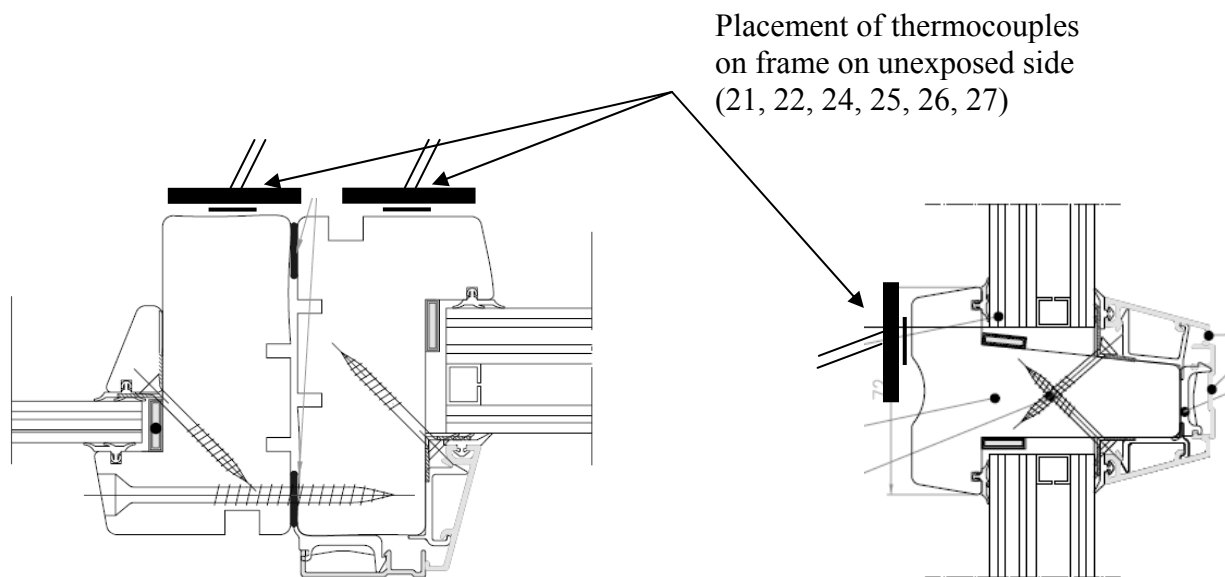
Figure 1 Sketch (not in scale) of instrumentation on the specimen.

The sketch shown in figure 1 shows the location of the measurements on unexposed side.

Positions for instrumentation:
 -TC 13-20 located in center of 1/4-part of each glass
 -TC 23-25 and deflection 11 and 12 located in half height of specimen
 -Radiation located 1 meter from center of specimen

⊗ Thermocouples • Deflection measurements ☼ Radiation measurement

- Thermocouples on unexposed side for registration of temperature.
- Deflection measurements approximately in centre of test specimen and in half height at free edge.
- Radiation measurements in centre of test specimen.

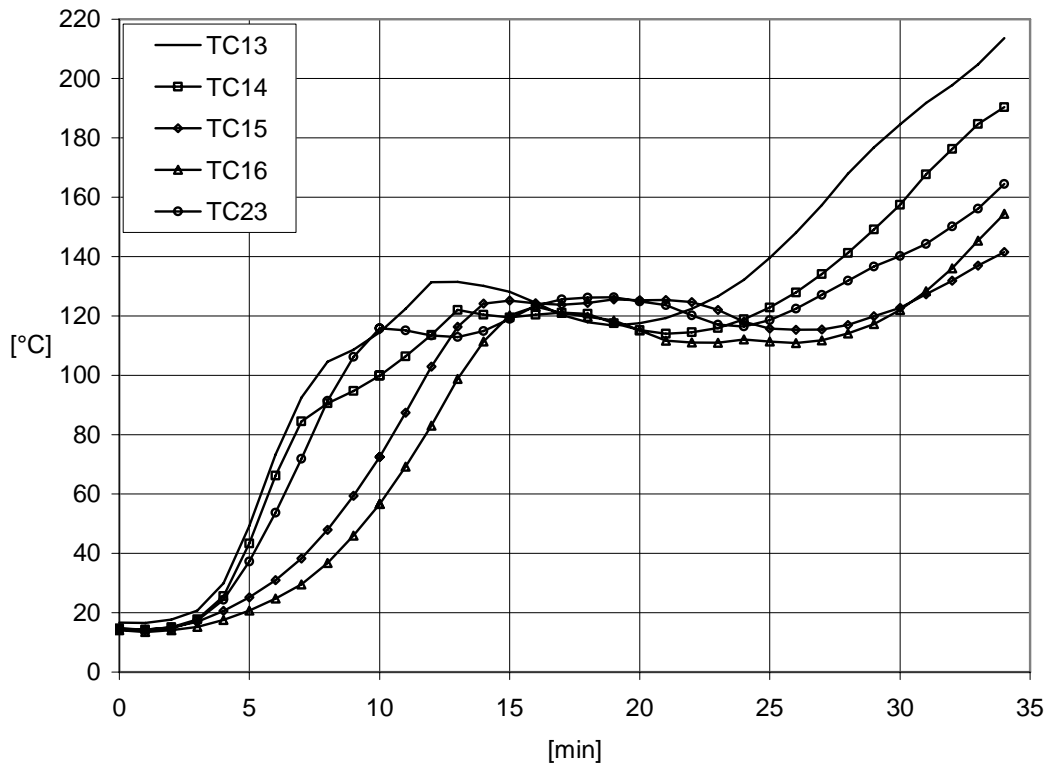
Figure 2 Temperature measurements on unexposed side of glass pane A1 and A2.

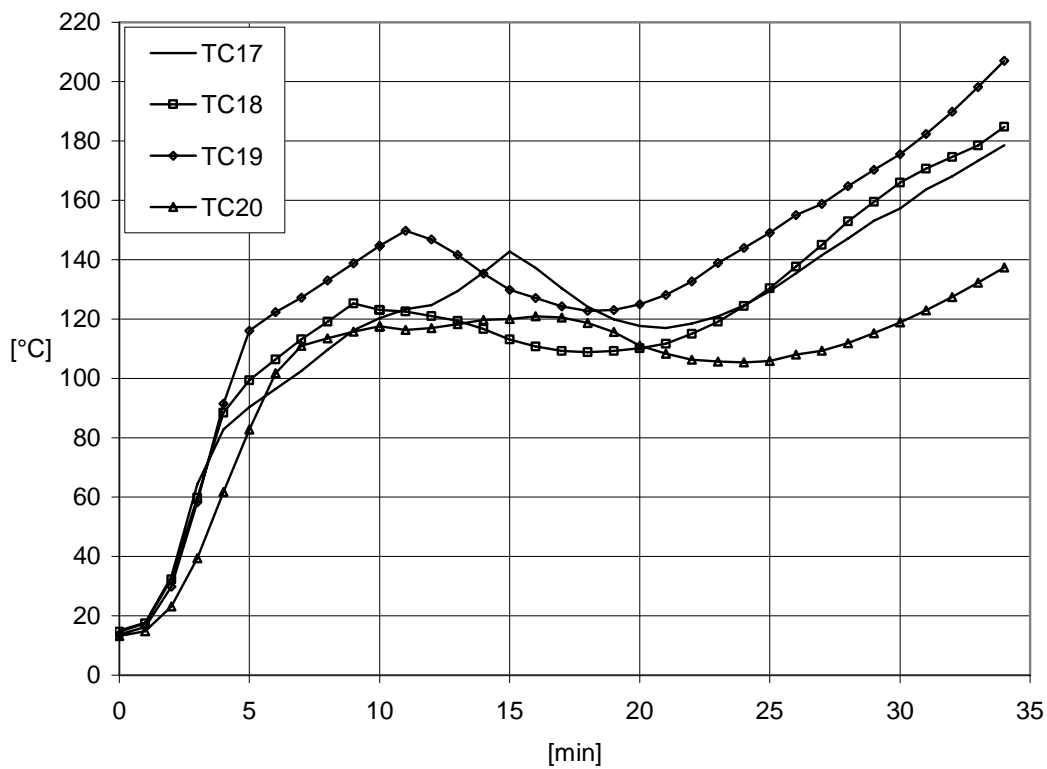
Figure 3 Temperature measurements on unexposed side of glass pane B1 and B2.

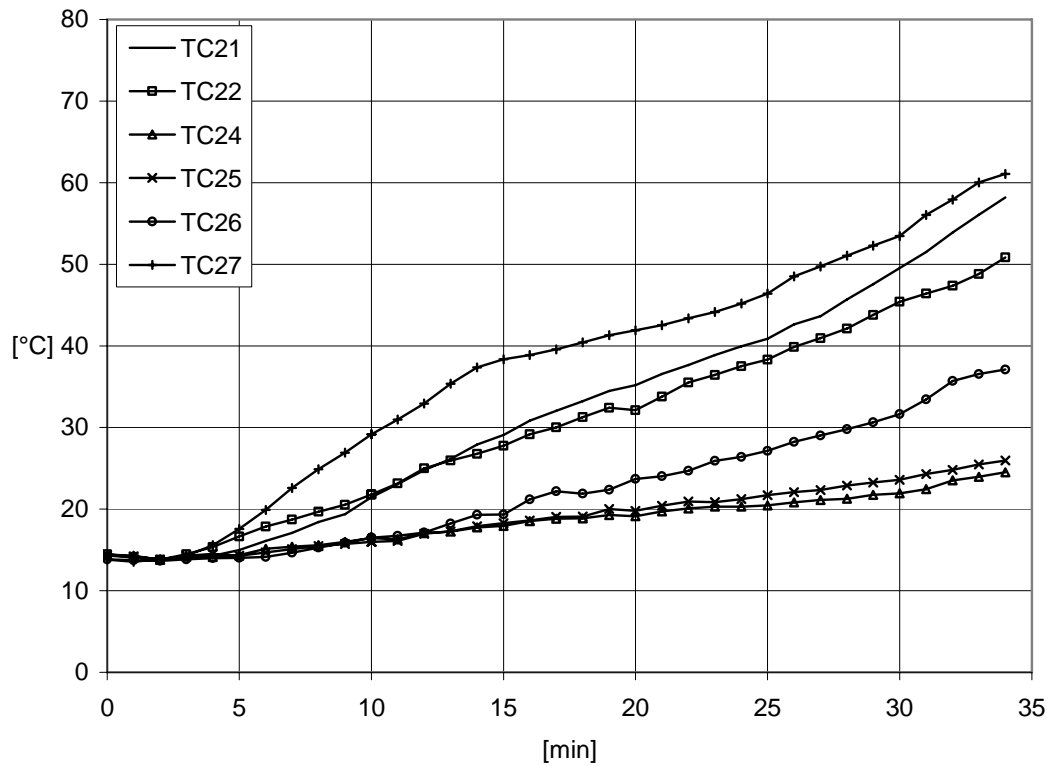
Figure 4 Temperature measurements on unexposed side of the framework.

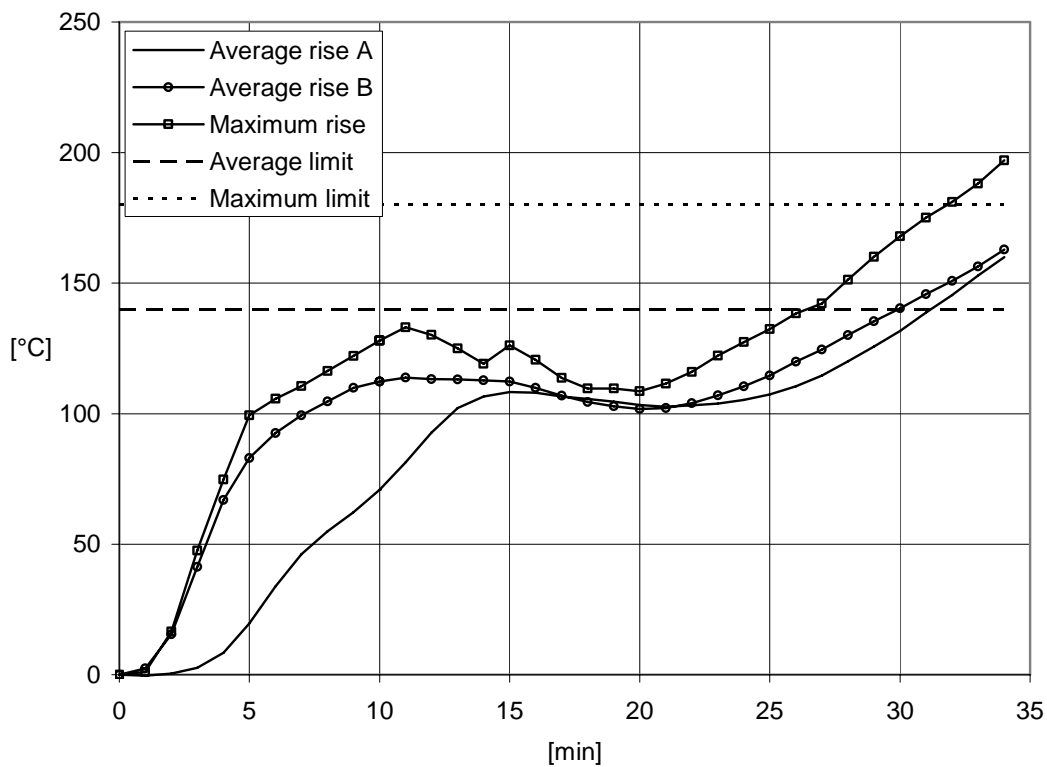
Figure 5 Average- (TC 13-16 for A and TC 17-20 for B) and maximum (TC 13-27) temperature rise on unexposed side of the test specimen.

Test duration:	34 minutes
	Time in completed minutes without criteria failure:
- Integrity:	- Sustained flaming: 33 minutes
	- Gap gauge: 34 minutes
	- Cotton pad*: 34 minutes
- Insulation:	31 minutes for Pyrobelite 12EG 16-15-6 (element A)
	30 minutes for Pyrobelite 12 (element B)
- Radiation:	34 minutes

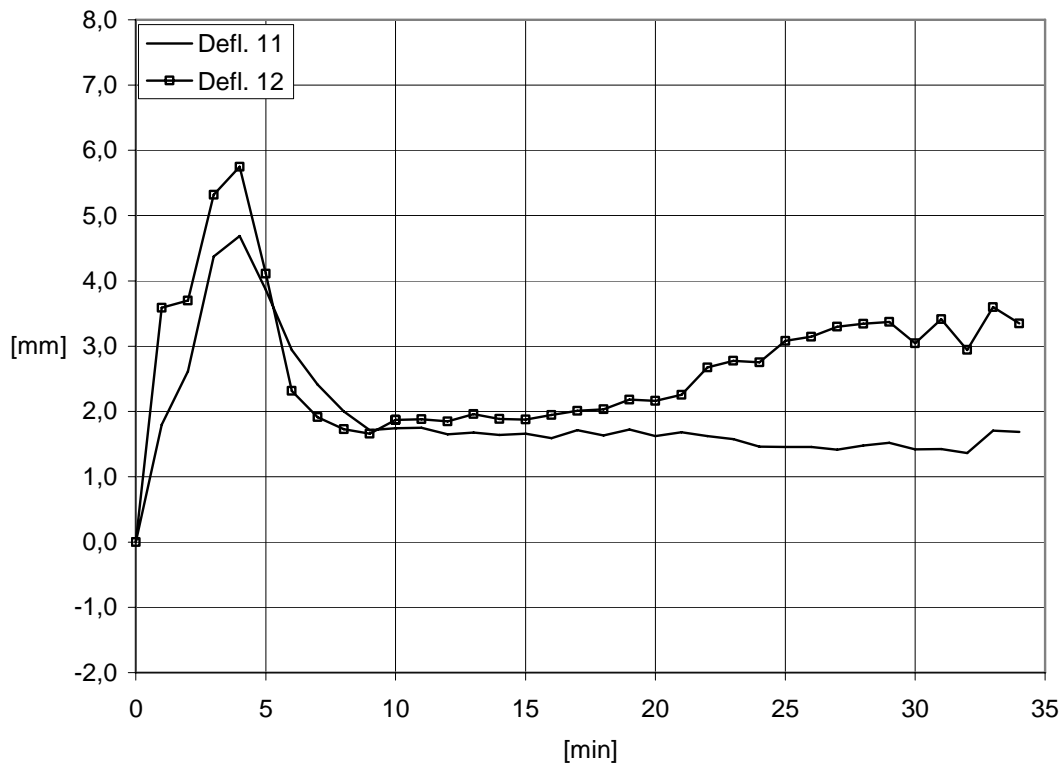
Figure 6 Deflection of the construction, measured in approximately centre of the specimen and in half height on the free edge. Positive values indicate deflections towards the furnace.

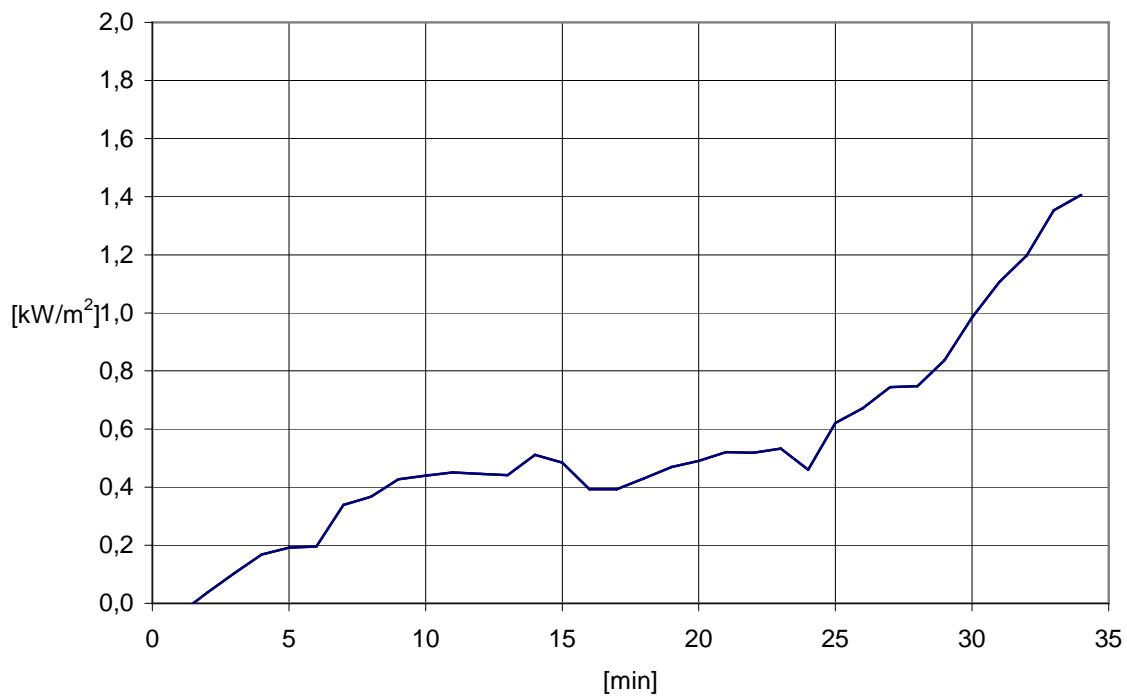
Figure 7 Radiation from the unexposed side of the test specimen, measured approximately 1 meter from the centre of the specimen.

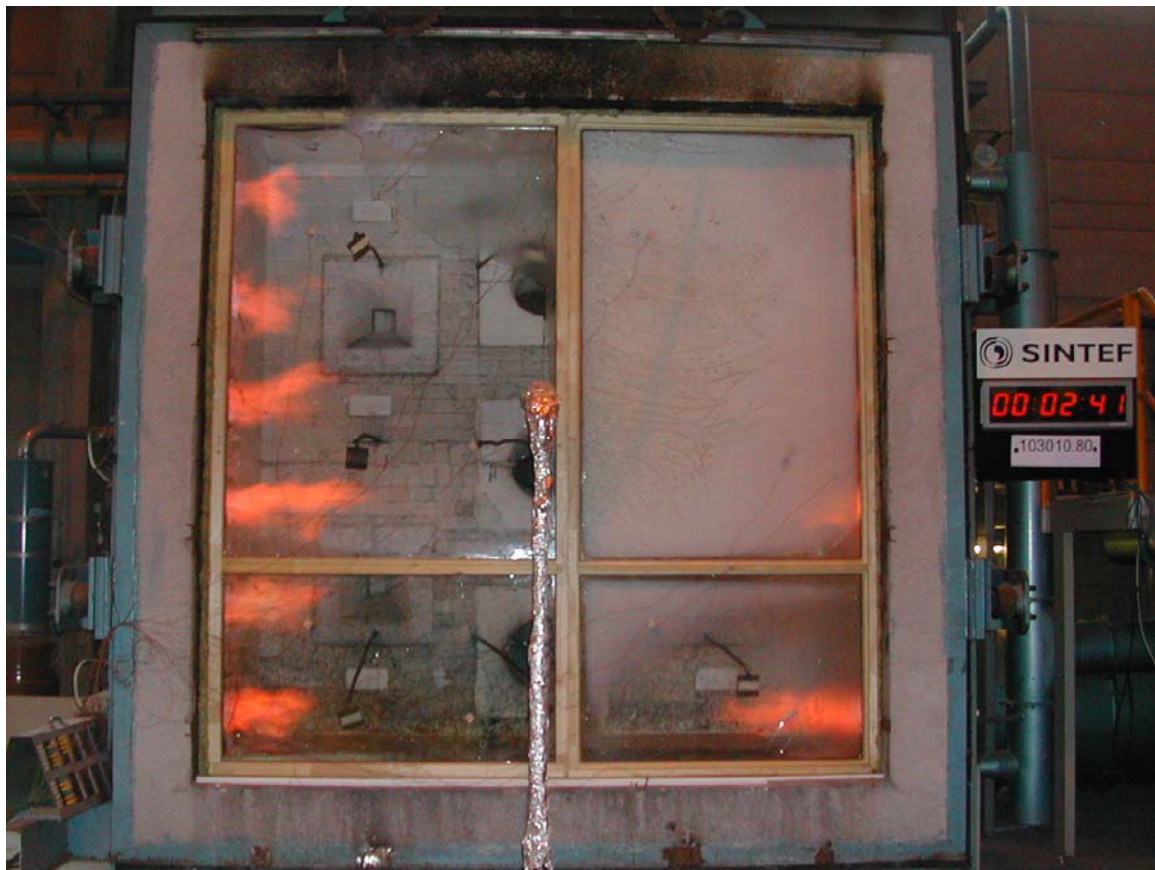
Photo 3: *Unexposed side of the test specimen after 2 minutes and 41 seconds of fire testing.*

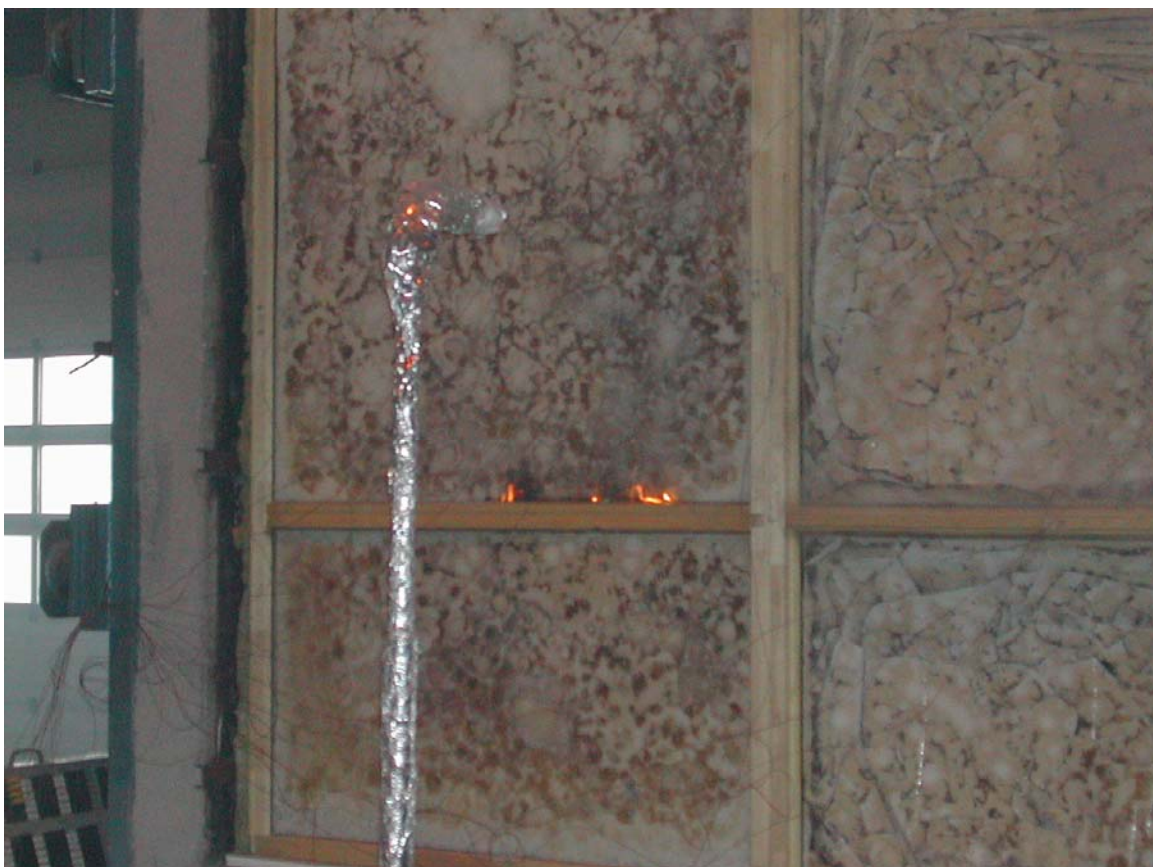
Photo 6: Unexposed side of the test specimen after failure due to sustained flaming.

29:30	Cotton pad test performed on the top of B1. No criteria failure.
31:00	Cotton pad test performed on the top of A1. No criteria failure.
33:40	Sustained flaming from bottom of A1 which causes criteria failure.

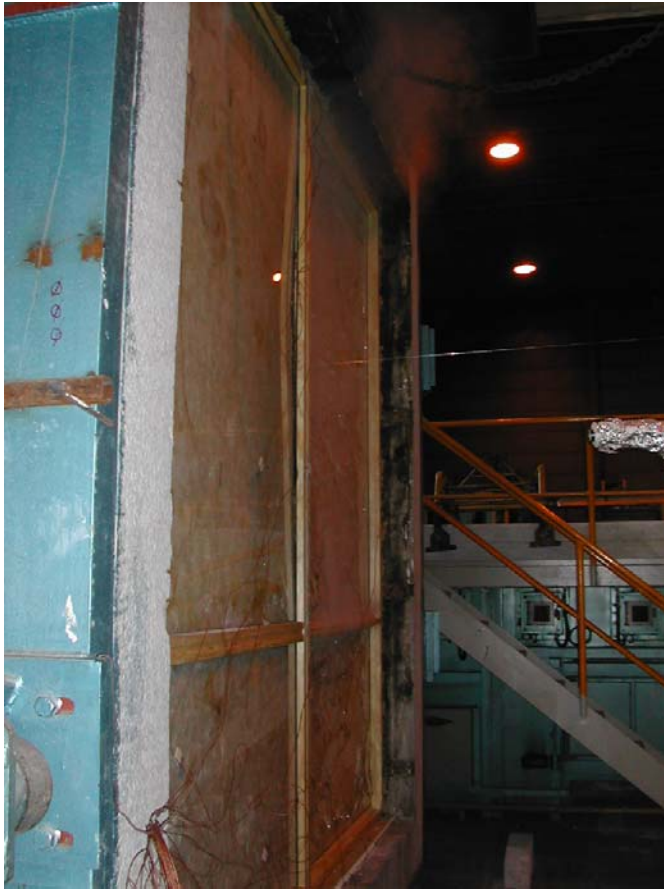
Photo 9: Unexposed side of the test specimen. The glass bends into furnace and have a displacement from flange.

18:10	The glass in A1 is loose and bends into furnace. Between the angle profiles (detail 16 on drawing 1003) along the vertical edges, the glass has a displacement on about 2 cm. See photo 9.

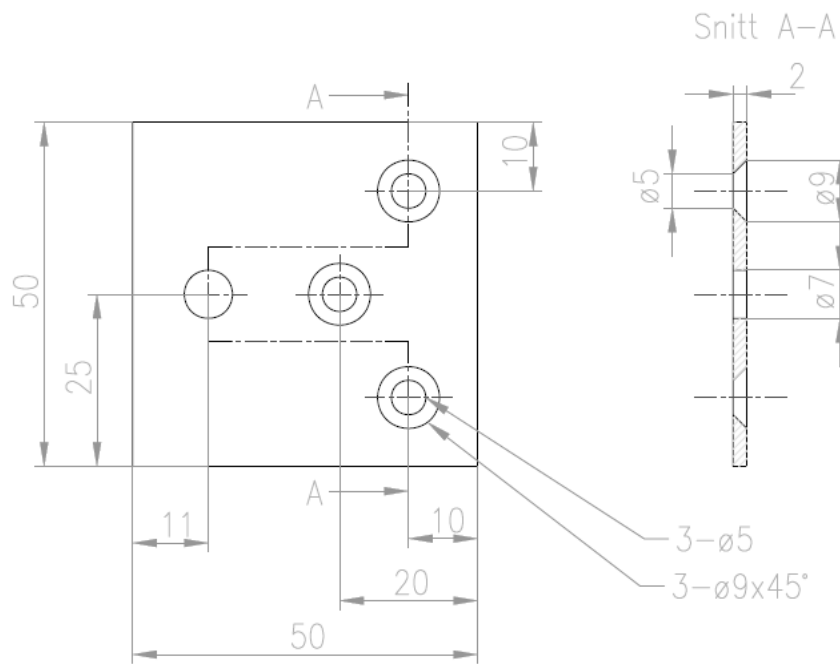
BSL, brakett for innfesting FKN brannvindu

The screws in the connection between the elements and between the specimen and test frame were secured by fittings. The fittings were 50 x 50 mm and were made of 1,9 mm thick steel. In addition to the fastening screw, the fittings were screwed on the frame with three 4,5 x 40 mm screws. Se drawing 569 for details.

Matr. : Stål ubehandlet.

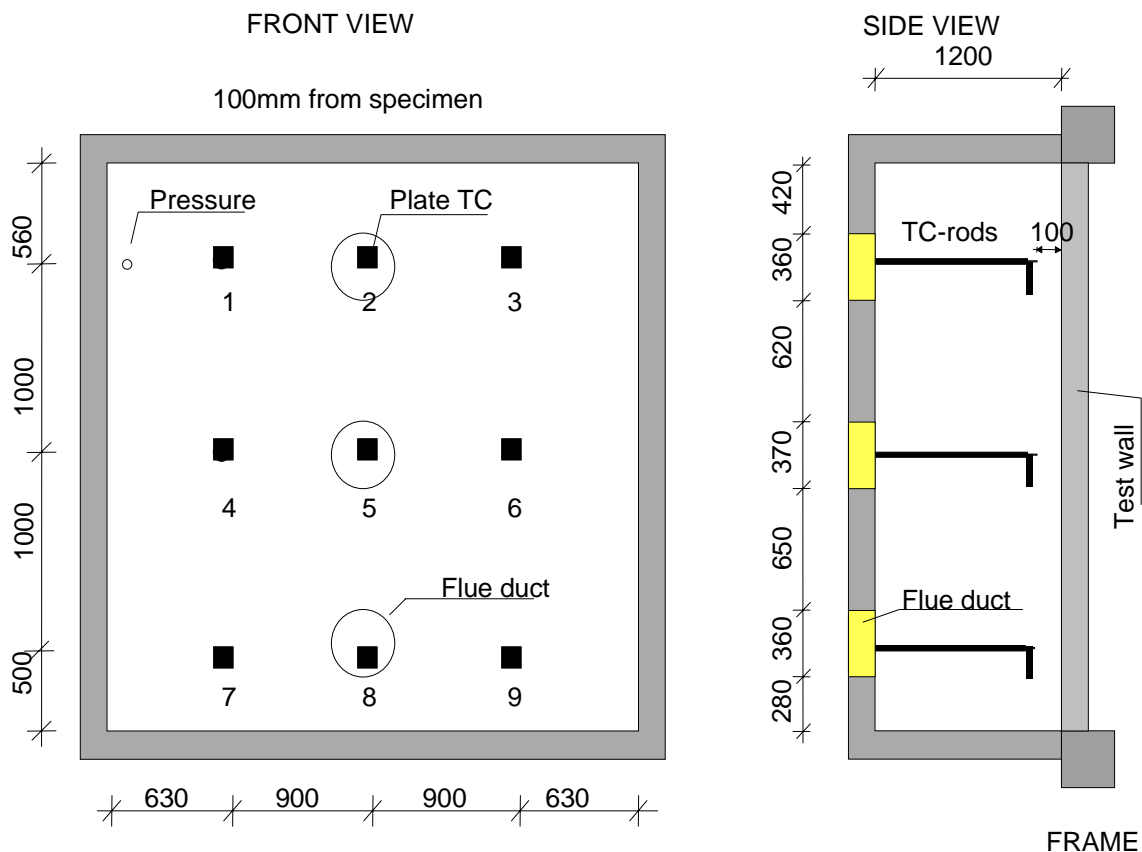
The temperature was measured with 9 plate thermocouples, located 100 mm from the exposed side of the specimen, evenly distributed as shown in figure I.1.

Figure I.1 Location of thermocouples and pressure gauge inside the furnace, 100 mm from the exposed side of the test specimen.

The test was carried out in the laboratory's gas-heated wall furnace. The furnace has inner dimensions 3060 x 3060 x 1200 mm. See Figure I.1.

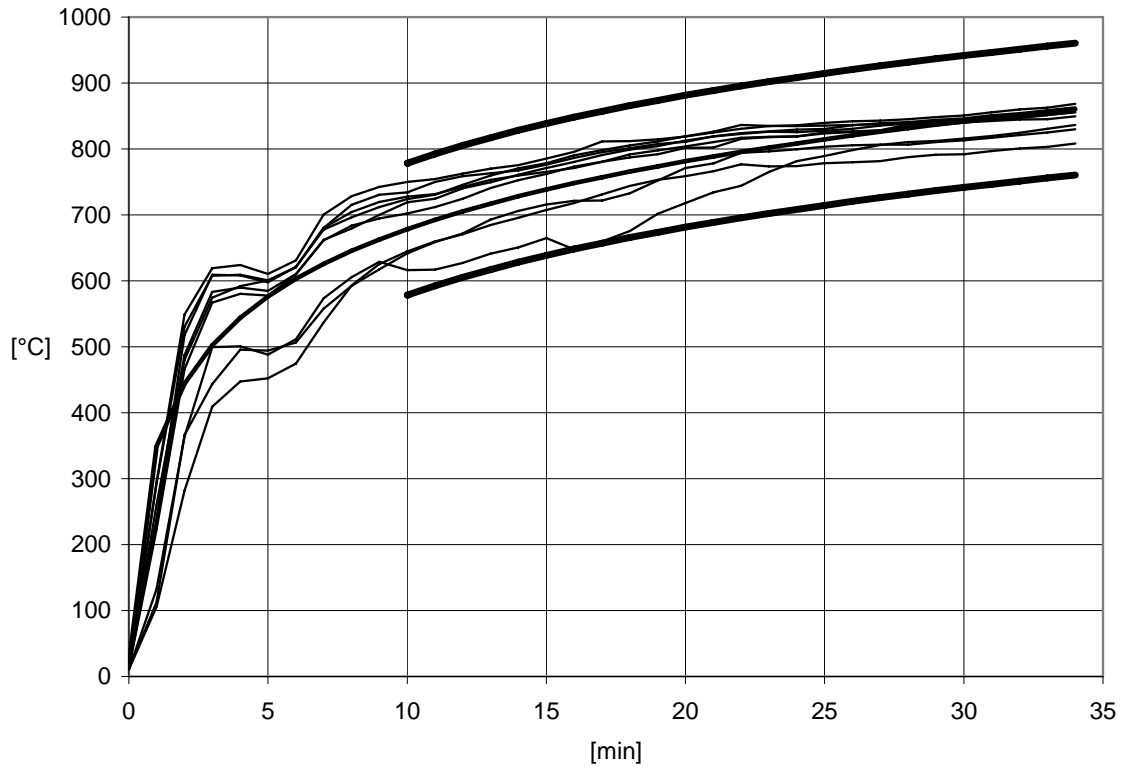
Figure I.2 Furnace temperature and the standard time- temperature curve. Deviation limits after 10 minutes.

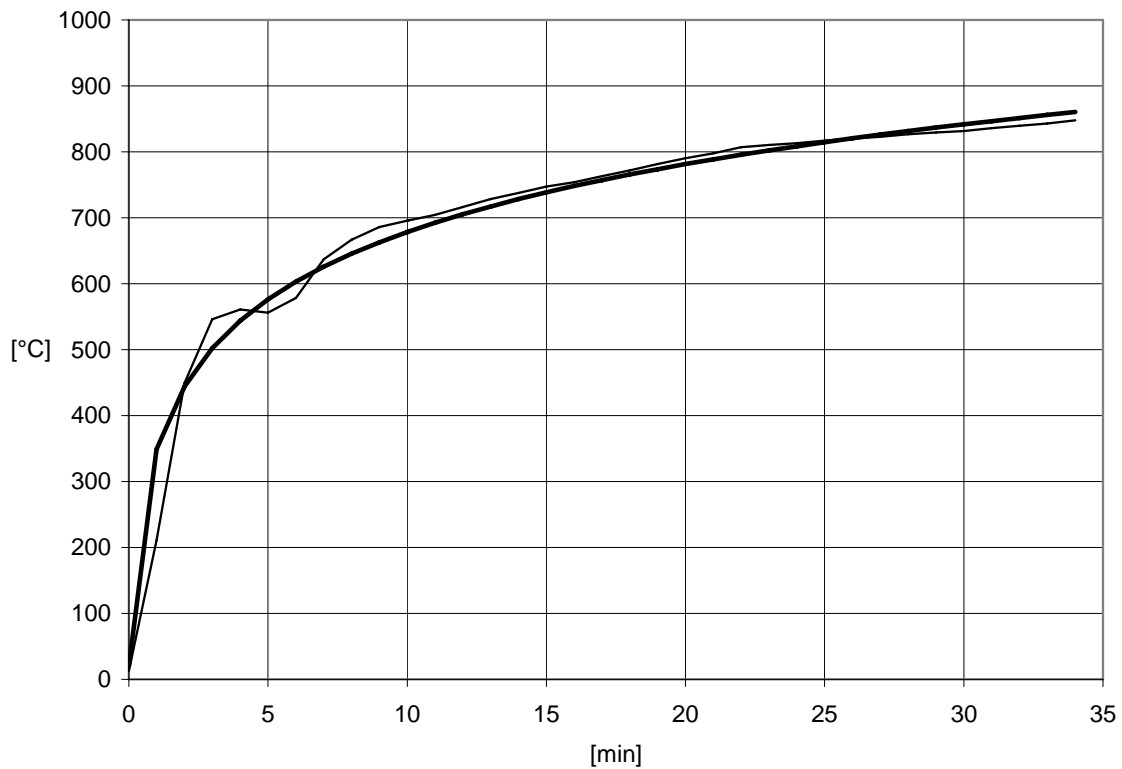
Figure I.3 Average temperature in furnace, and the standard time- temperature curve.

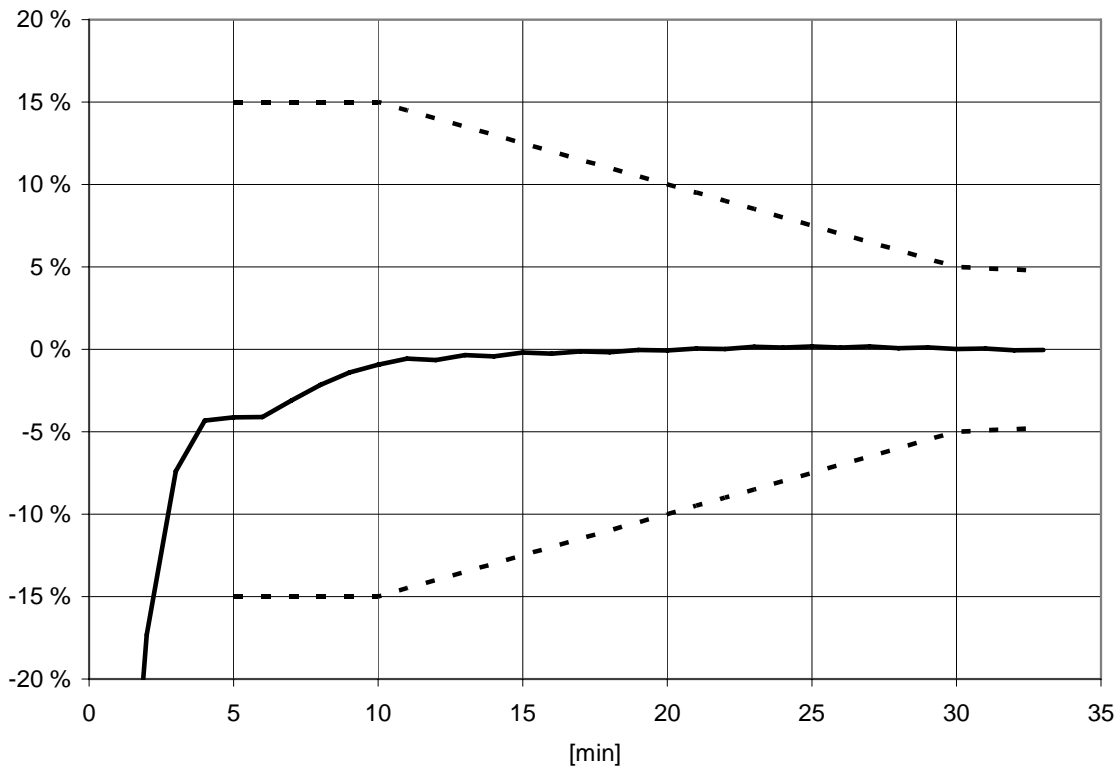
Figure I.4 Percentage deviation between average furnace temperature and standard time-temperature curve. Deviation limits after 5 minutes.

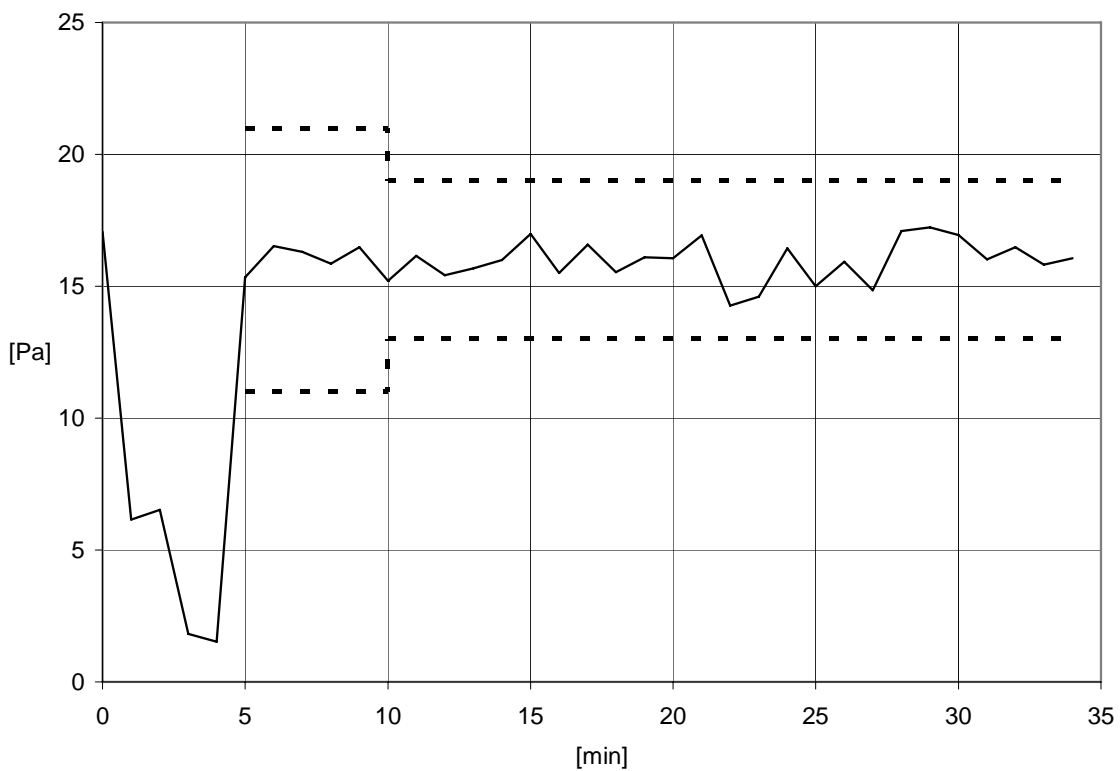
Figure I.5 Pressure in the furnace, measured at 2,5 m above furnace floor. Deviation limits after 5 minutes. Intended furnace pressure: 16 Pa.

The pressure in the furnace was measured by means of a pressure sensor of Type 1 ("T"-shaped sensors). The pressure sensor was located 2500 mm from the test furnace floor. The calculation of the furnace pressure is in accordance with NS-EN 1363-1, section 5.2.
